**Ball Head System screw and driver study:
Evaluation of torsion resistance at 0°, 20° and 30°**

PROJECT NUM. SER12-06

**Document issued by the UPC Materials Sciences and
Metallurgical Engineering Department for Ball Head System**

16th April, 2012

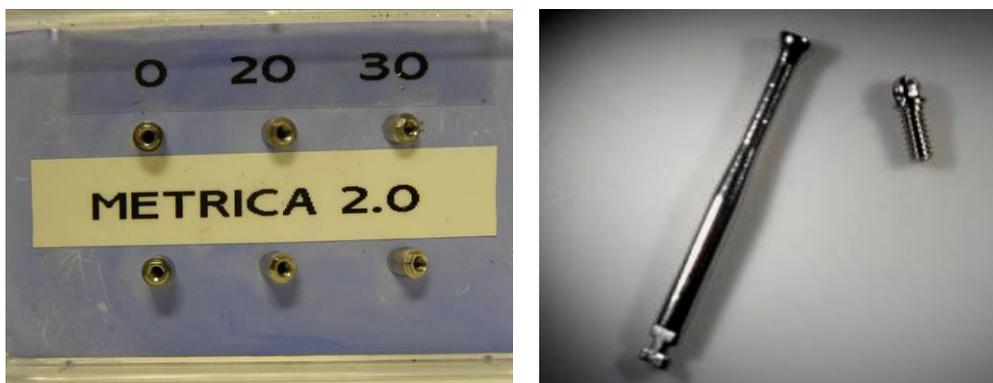
Figure 1. Workbench with 3 angulations to test (left). BHS driver and screw set (right).

1. Workbench with six dental implants fixed in angulations of 0°, 20° and 30°.
2. 12 samples of BHS driver and screw sets (screw ref. M2x0,4 HE 4,1mm Ti).
3. 9 samples of BHS driver and screw sets in three different surface treatment conditions (TiN, CrN and DHC-TR coatings).
4. 3 samples of Allen Ball driver and screw sets (screw ref. TPD2+, Talladium, Lleida).

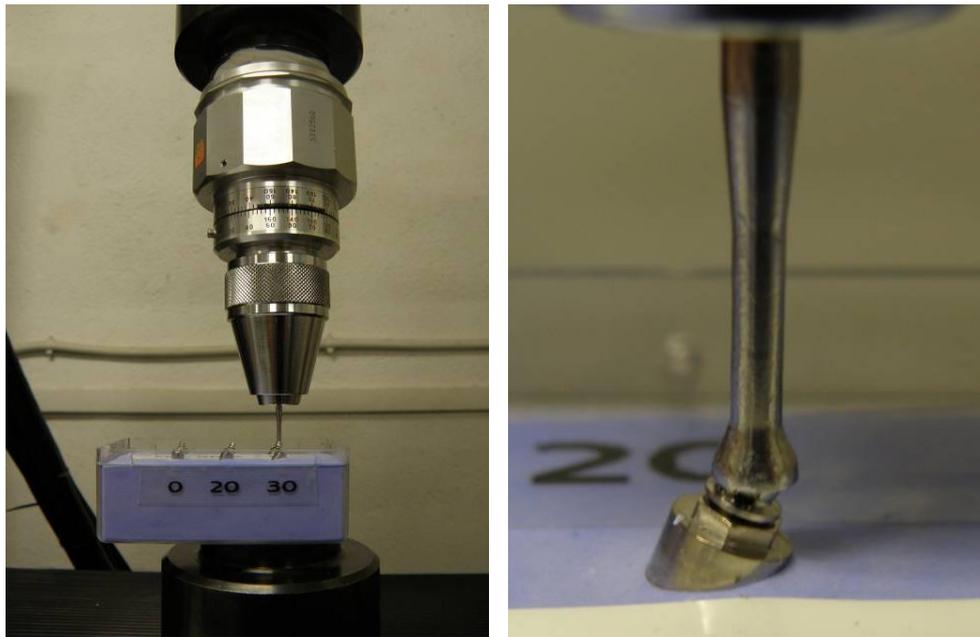
Figure 2. Assembly of the analogical torquimetre for the test set.

Torsion resistance of all driver and screw sets supplied by Ball Head System was evaluated with an analogical torquimetre (model BTG150CN, Tohnichi), by applying a progressive torque until failure of any of the components occurred, as it can be seen on Figure 2. All tests were made by the same technician and supervisor, according to the same procedure and materials.

The workbench was fixed on a grooved metallic bench. Drivers were fixed through their antirotational device, gripped on their ISO 1797 shaft and 4 mm below it, by a dental handler adaptor (ref. CCUNIO, Talladium, Lleida). Tests were divided into the following different tasks:

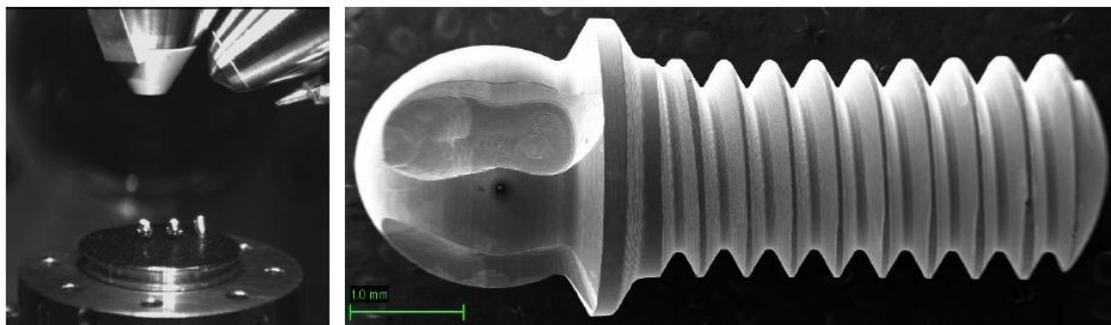
Figure 3. BHS screws inside the FESEM room (left) and BHS screw observed through the FESEM (right).
Bar indicates 1 mm.

Detailed images of the screw and driver sets have been taken with a binocular microscope before and after each test. In the iteration tests, images were obtained by using a scanning electronic microscope FESEM (JSM-7001F, Jeol, Japan).

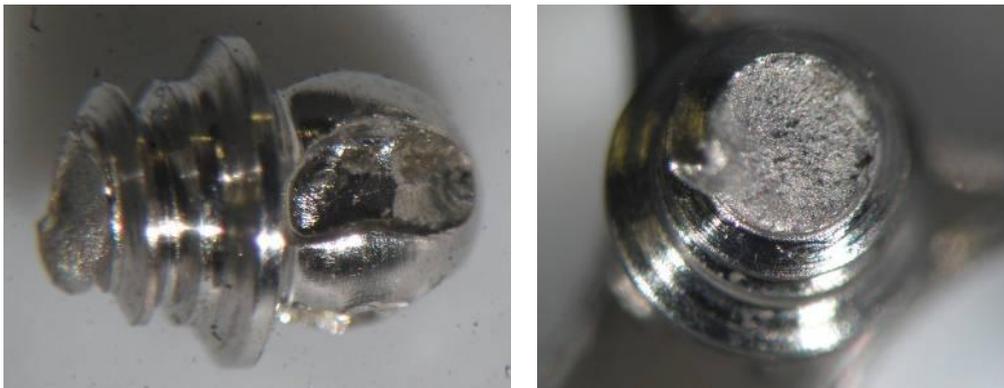
Figure 4. Details of the broken thread (left) and image of the fracture surface (right).

There is only one screw with this type of ductile fracture, sample M1 at 0°. Maximum torsion reached at the moment of fracture was 110 N·cm. This torsion torque figure was the highest one reached in all the tests. Furthermore, it was observed that the screw head grooves had undergone through less deformation when compared to the rest of the screws tested at 0°.

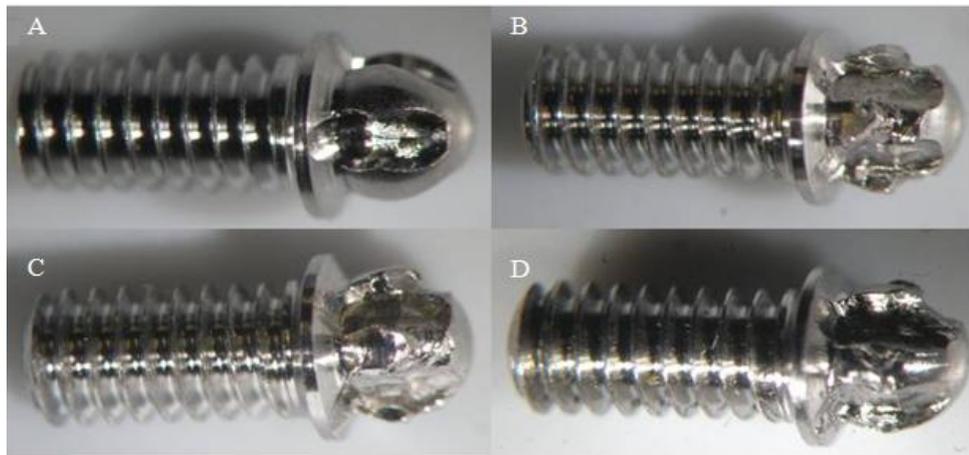
Figure 5. BHS screw broken by the grooves. (A) Non tested screw, (B) tested at 0° , (C) at 20° and (D) at 30° .

A wide majority of the tested sets experienced failure by the screw's head grooves in contact with the driver protuberances. In these cases there was a variable deformation of the screw head, which was the main cause of the set failure. Furthermore, it was observed that higher angulations would cause slight increases on the plastic deformation of the screw's grooved head area.

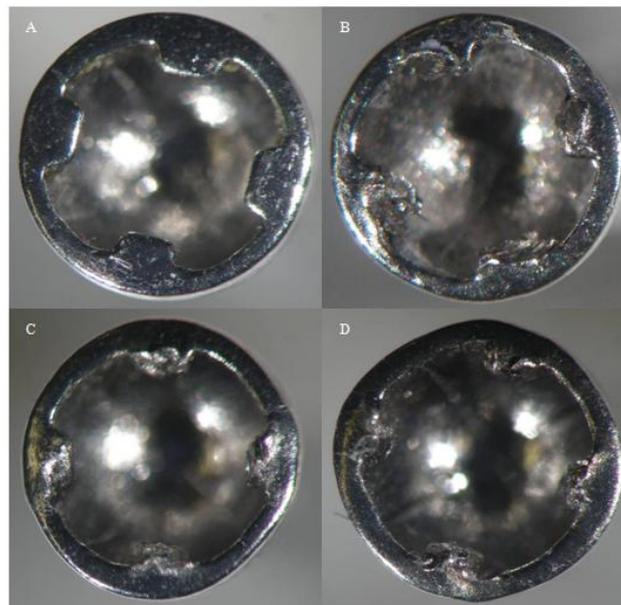
Figure 6. Driver inner aspect without deformation (A), driver tested at 0° (B), driver tested at 20° (C) and driver tested at 30° (D).

The same pattern was observed in the case of the driver, although with more pronounced deformation of its interior walls and protuberances as the angulation of the test increased. Plastic deformation of the metal was concentrated on the contact surface between the driver and the screw, due to the mechanical load concentration on these areas.

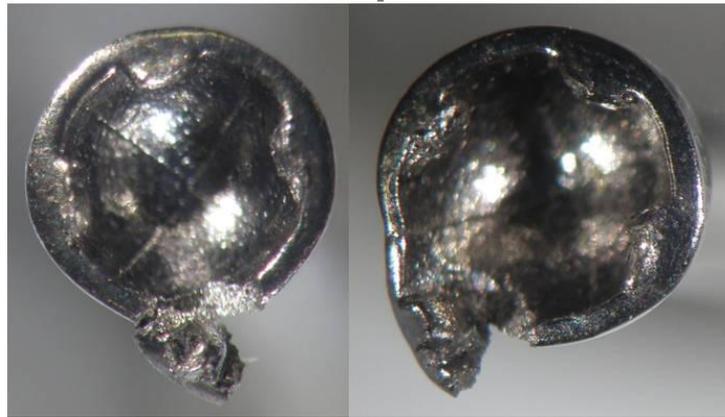
Figure 7. Interior details of the BHS driver tested at 20° (right) and 30° (left).

In one of the test at 20° and another one at 30° , some deformation of the screw's grooves together with a breakage of the driver walls were experienced, as shown in Figure 7. Despite of the driver's walls breakage, the tool also suffered some interior plastic deformation, absorbing part of the torque force. Another notable fact is that in both cases these sets were the most resistant ones among all the samples.

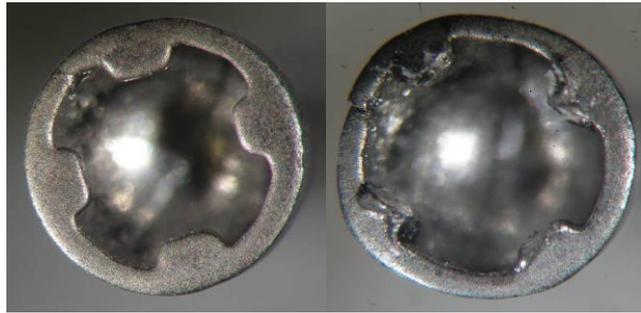
Figure 8. Inner details of the BHS driver CrN coating before (left) and after the test (right)

The tests made with the CrN coated drivers presented lower maximum torque data in comparison with other treated drivers performance; although the differences were not statistically significant.

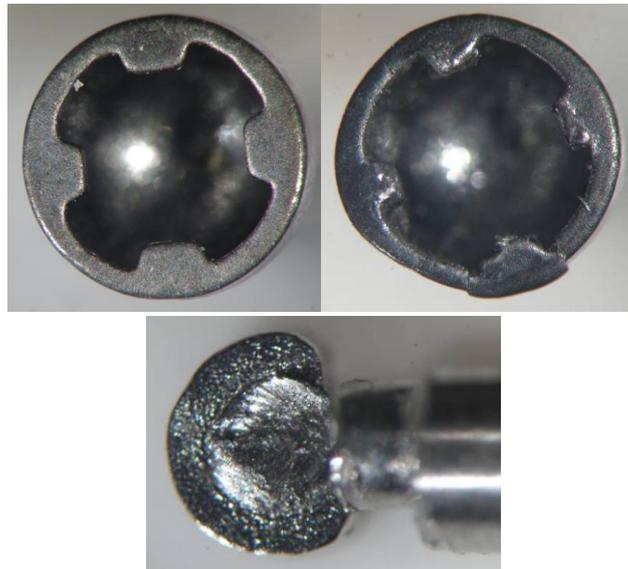
Figure 9. Interior details of the BHS driver coated with DHC without testing (left), after testing (right) and breakage surface of the upper part of the driver (bottom).

The drivers coated with DHC presented the highest torsion resistance. In this case, the drivers were deformed in their internal geometry, and in one of the samples, even the ISO1797 connection with the torquimetre -non coated- was broken, see Figure 9.

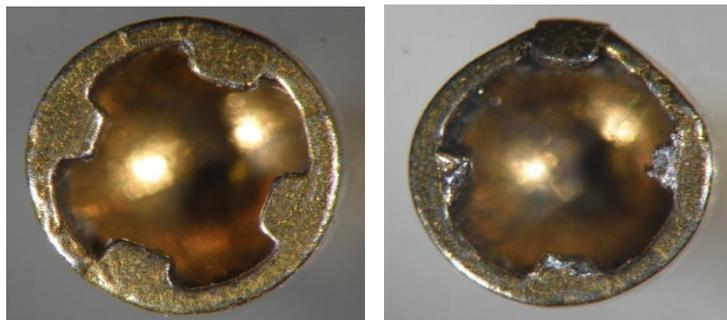
Figure 10. Interior details of the BHS driver coated with TiN before (left) and after testing (right).

Finally, the TiN coated drivers showed a maximum torque performance and a failure typology similar to the drivers coated with CrN surface treatment, slightly improving the results.

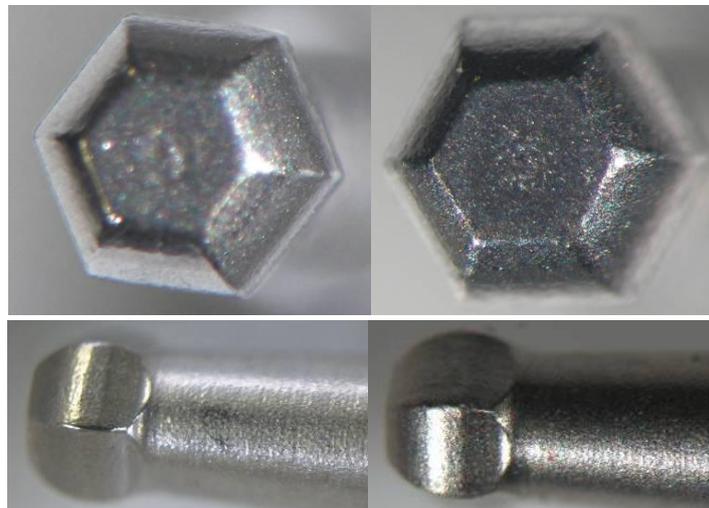
Figure 11. Original Allen Ball driver (left) and driver after testing (right).

In this case there was only one type of breakage: the drivers did not show significant deformation, as it is seen on Figure 11, while the inner part of the screws showed an important plastic deformation with some loss of material, as shown on Figure 12. In all these three cases, therefore, the driver-screw set failed due to the screw deformation, which had to be unscrewed with a workshop pressure key, which is a difficult tool to use in prosthetic restoration.

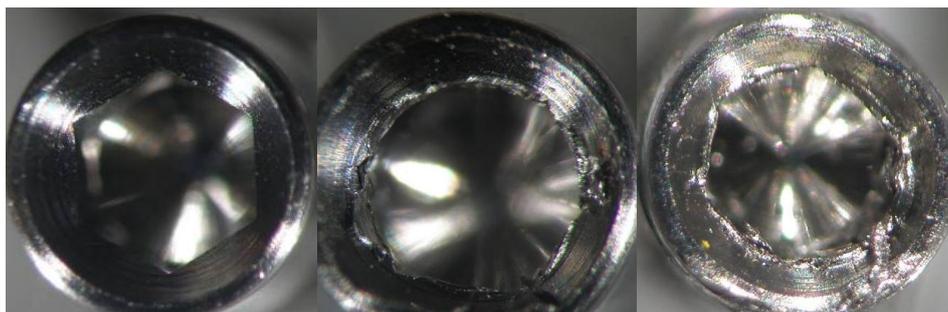
Figure 12. Original Allen screw (left) and screws, once tested (centre and right).

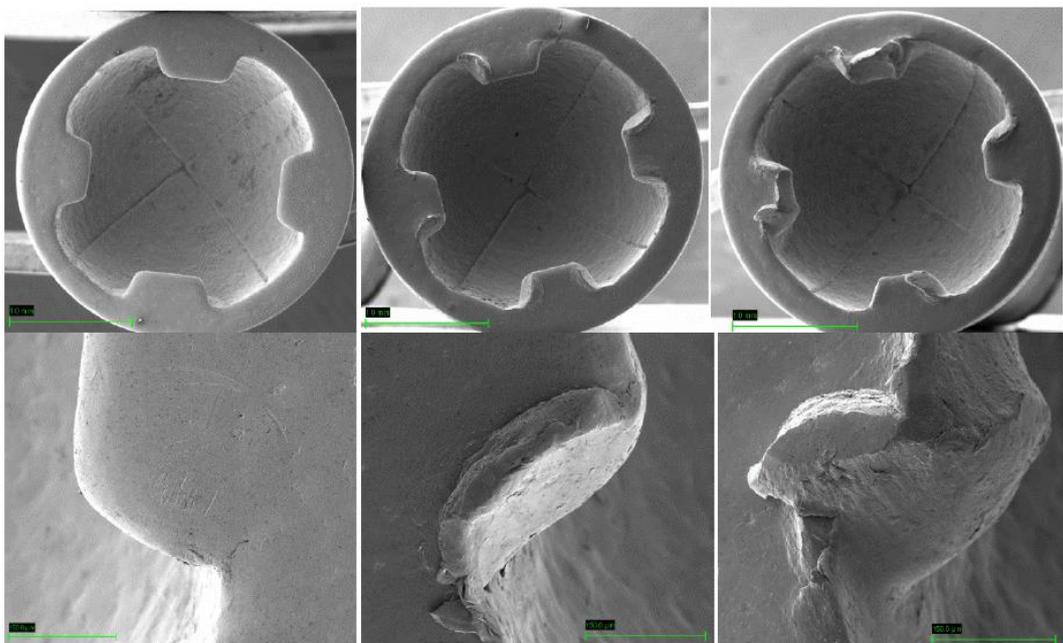
Figure 13. Detail of the original BHS driver (left), the driver after 10 iterations (centre) and the driver after 30 iterations (right). The upper bars show 1,0 mm and the lower ones 150 µm.

After 10 iterations a deformation on the driver was noticed, located in the area corresponding to torque sense, and a minimum deformation in the opposite sense, due to the torque that was applied for loosening the screws and prepare them for the next iteration.

In the case of 30 iterations, the driver became more deformed than in the previous test when referring to the torque sense area of the tool's protuberances, as it is seen on Figure 13. Nevertheless, all sets could be screwed and unscrewed easily through the complete round of iterations, although deformation appearing on the loosening sense is also slightly higher than in the 10 iterations test.

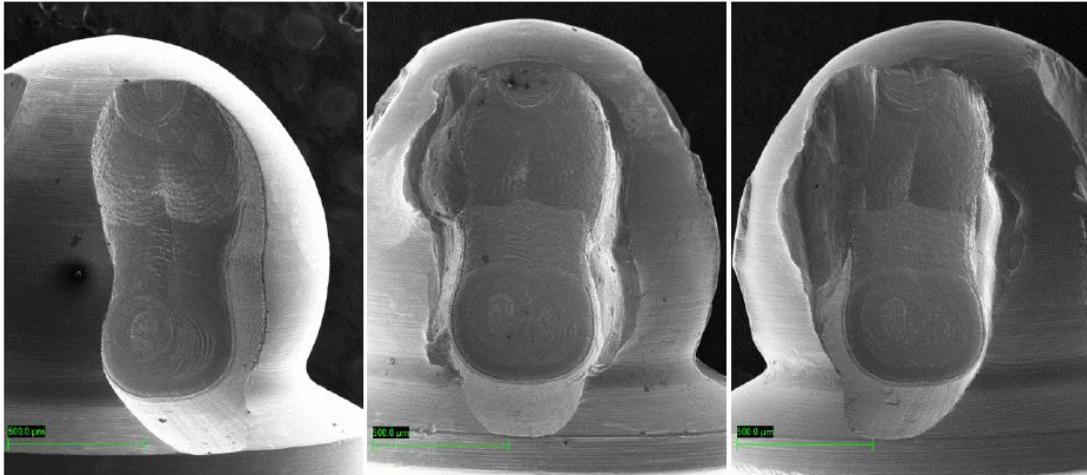
Figure 14. Detail of the original grooves of the BHS screw (left), after 10 iterations (centre) and after 30 iterations (right). The bars show 500 µm.

Regarding the screws, they showed some deformation on the head grooves in both cases, but it was in the 30 iterations test where the deformation experienced was bigger, see Figure 14. Nevertheless, as mentioned before, this deformation would not prevent the test to continue until all iterations had been performed.

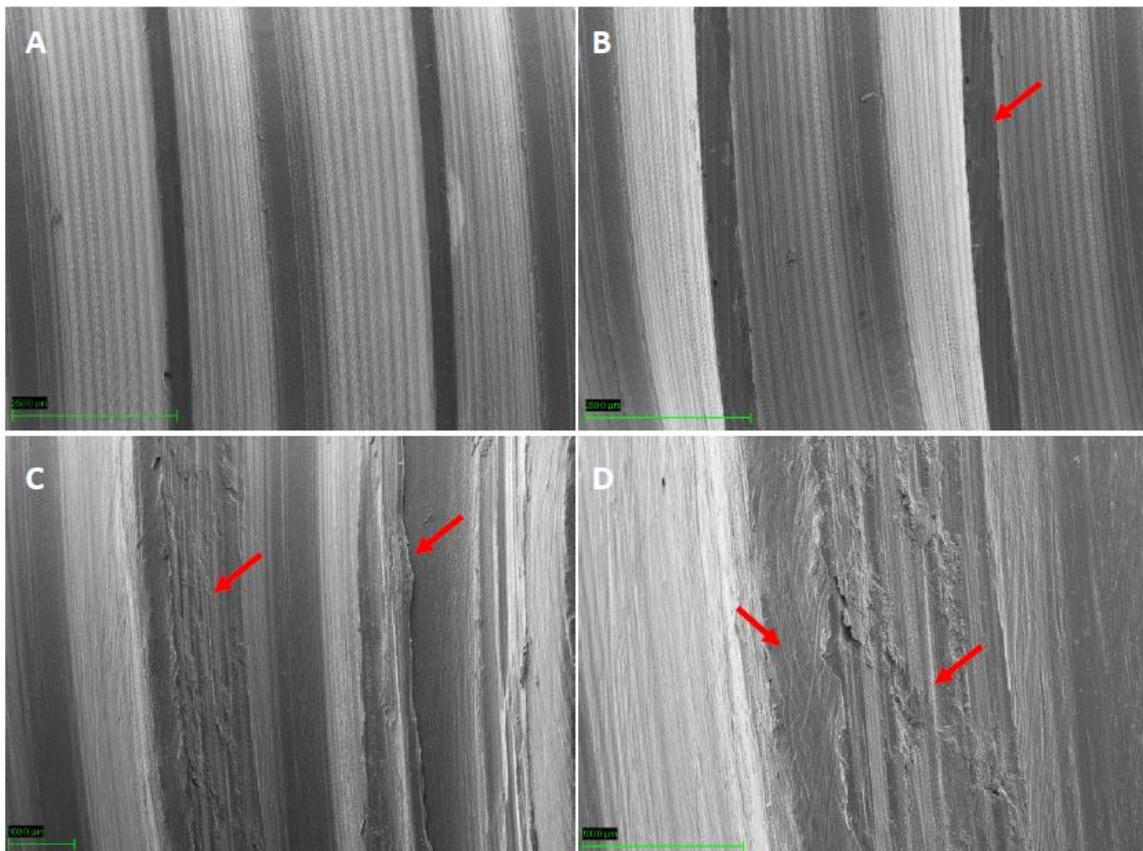
Figure 15. Details of the BHS original screw's thread (A), screw after 10 iterations (B), the screw after 30 iterations and an enlargement of the superficial erosion observed after 30 iterations (C and D). The upper bars show 250 µm and the lower ones 100 µm.

In addition, the wear due to the different iterations can be seen in the thread turns, as observed on Figure 15.

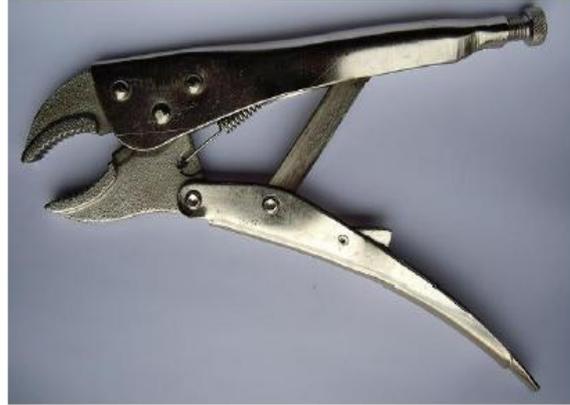
Figure 16. Picture of a workshop pressure key

After the test execution, it was impossible to extract the TiN-Num. 3 and CrN-Num. 3 samples off the workshop implants because the grooves in the screw were completely damaged so it could not be removed neither with a new driver nor with a workshop pressure key (see Annex 5.1.). We finally tried to remove them by milling a clamping slot around their perimeters, also unsuccessfully. This fact caused the disabling of the device at 30°.
