## **Ball Head System screw and driver study:**

### **Comparative evaluation of torsion resistance**

**PROJECT NUM. SER12-06**

**Document issued by the UPC Materials Sciences  
and Metallurgical Engineering Department**

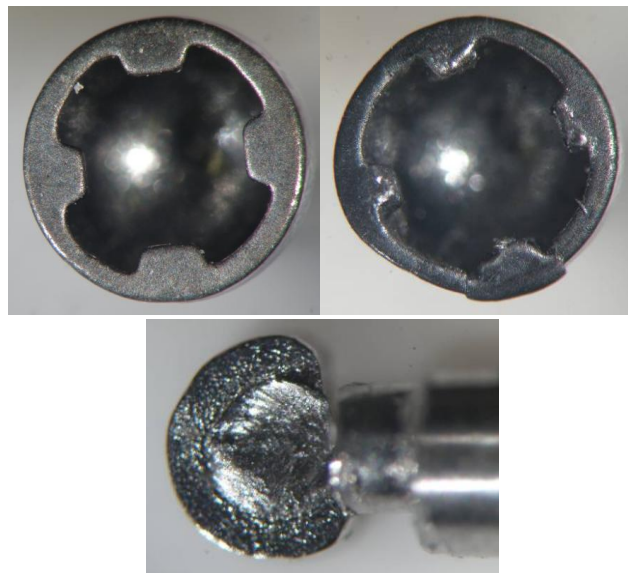
**Figure 9.** Interior details of the BHS driver coated with DHC without testing (left), after testing (right) and breakage surface of the upper part of the driver (bottom).

The drivers coated with DHC presented the highest torsion resistance. In this case, the drivers were deformed in their internal geometry, and in one of the samples, even the ISO1797 connection with the torquimetre -non coated area- was broken, see Figure 9.

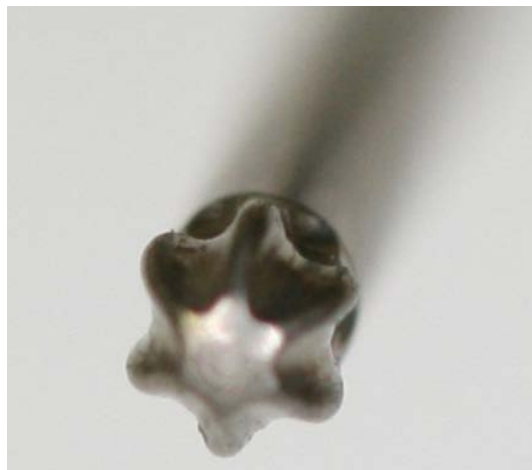
**Figure 13.** Hexalobular driver after testing (right).

Hexalobular driver-screw sets also presented a single type of failure: the drivers did not show any signs of deformation after their use, as it can be seen on Figure 13, while the interior recess of the screws showed important plastic deformation with significant loss of material, localized mainly in the grooves, as it is shown on Figure 14. In all the cases with these samples, therefore, the driver-screw set failed due to the screw deformation, which led to a complete loss of gripping capacity and had to be unscrewed with a workshop pressure key, which is a difficult tool to use in prosthetic restoration.

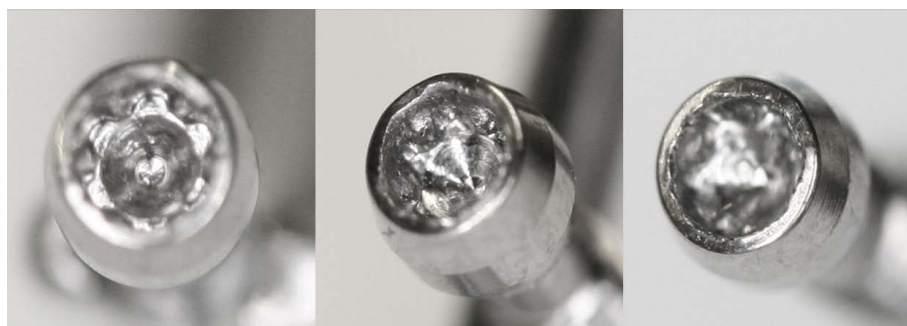
**Figure 14.** Original Hexalobular screw (left) and tested screws (centre and right).

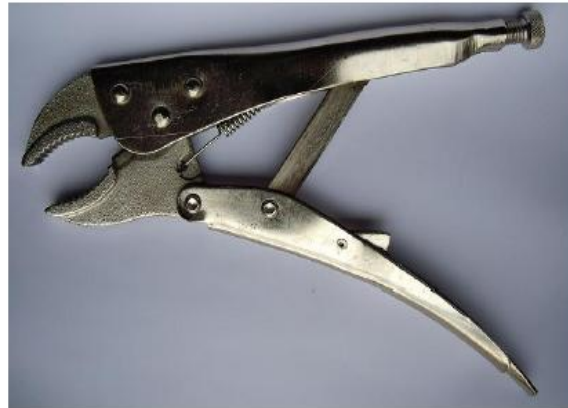
**Figure 18.** Picture of a workshop pressure key

After the test execution, it was impossible to extract the CrN-Num. 3 sample off the workshop implants because the grooves in the screw were completely damaged so it could not be removed neither with a new driver nor with a workshop pressure key (see Annex 5.1.). Finally, another attempt to remove it was done, by milling a clamping slot around its perimeter, also unsuccessfully. This fact caused the disabling of the device at 30 °.
